Manhole Inspection Summary

Manhole # S31M1_021MH

Location Address: **498 Cherry Hill Road** Cross Street: **Roundview Rd.**

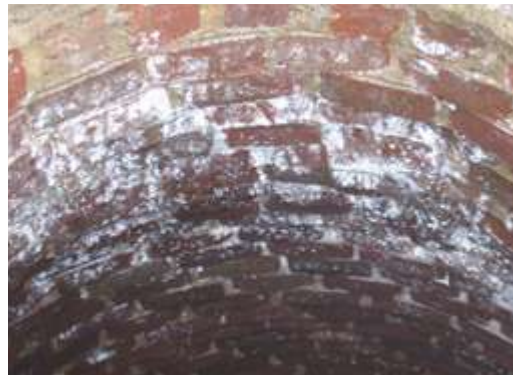
Defect 2

Wall

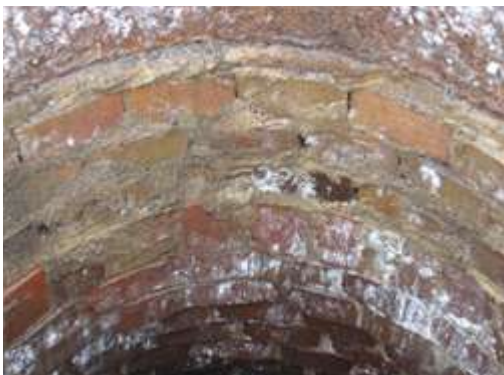
Defect 1

Corbel Material: **Brick** ☐ Parged Type: **Concentric/Eccentric**
Condition: ☒ Sound ☐ Cracked ☐ Root Intrusion ☐ Loose Brick ☐ Deteriorated
Infiltration: ☐ None ☐ Joint ☐ Cracks ☒ Mortar ☐ Roots ☒ Wall

Infiltration

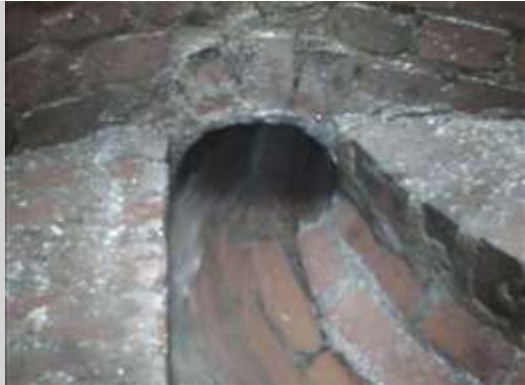
12 O'Clock Outflow

8 in. Circular Gravity Sewer
Pipe Out @ 12 O'Clock

Pipe Height: **10.8** (in.) Rod and Bar (Angled)
Pipe Material: **Clay** ☐ Pipe Lined
Invert Depth: **8.84** (ft.) Flow Characteristics: **Fast**
Deposits: ☒ None ☐ Mud ☐ Sludge ☐ Debris ☐ Grease
Silt Depth: (in.) Deposits Extent:
Infiltration: **None** Pipe Seal Cond: **Sound**

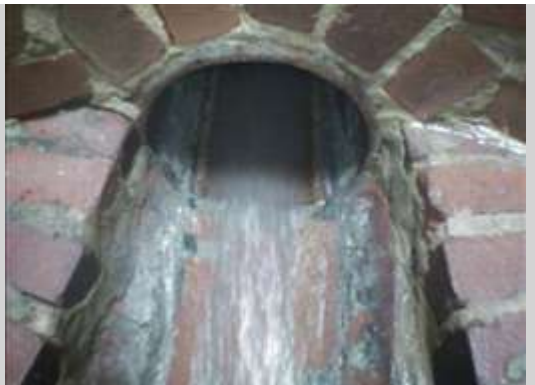
3 O'Clock Inflow

8 in. Circular Gravity Sewer
Pipe In @ 3 O'Clock

Pipe Height: **10.8** (in.) Rod and Bar (Angled)
Pipe Material: **Clay** ☐ Pipe Lined
Invert Depth: **8.19** (ft.) Flow Characteristics: **Fast**
Deposits: ☒ None ☐ Mud ☐ Sludge ☐ Debris ☐ Grease
Silt Depth: (in.) Deposits Extent:
Infiltration: **None** Pipe Seal Cond: **Sound**
